Department of Employment, Training & Rehabilitation
Employment Security Division
Nevada Job Connect Office - Elko
Facility Condition Analysis

# NEVADA JOB CONNECT OFFICE ELKO

172 6th Street Elko, Nevada 89801

Site Number: 9823 STATE OF NEVADA PUBLIC WORKS BOARD FACILITY CONDITION ANALYSIS

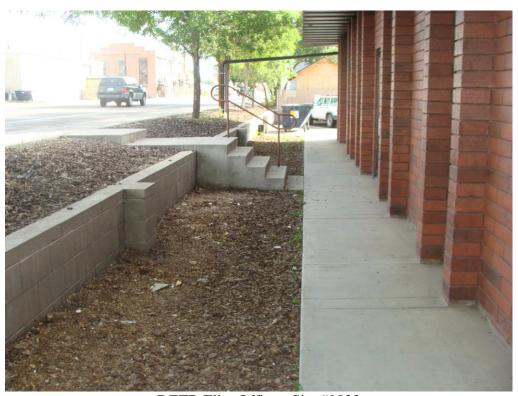
The handrail on the concrete stairs on the north side of the site is older and does not meet current code for safety. The gripping surfaces are incorrect, they do not have proper extensions and they are installed on only one side of the stair. This project recommends the installation of handrails in accordance with 2006 IBC Section 1012. Removal and disposal of the existing materials is included in the estimate.

DETR Elko Office - Site #9823 Description: Stairs in need of handrails.

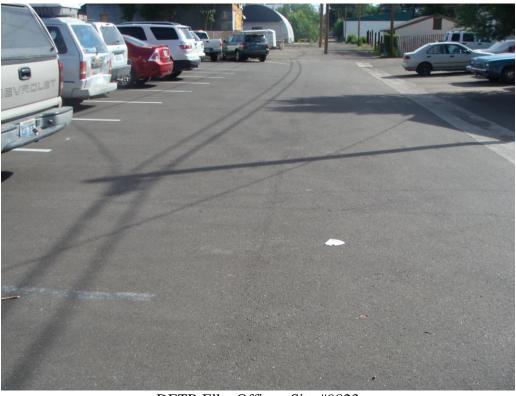
It is important to maintain the asphalt concrete paving on the site. This project would provide for minor crack filling and slurry sealing of the paving sitewide including access roads and parking areas. Striping is included in this estimate. This project should be scheduled on a 5 year cyclical basis to maintain the integrity of the paving and prevent premature failure. 10,000 square feet of asphalt area was used to generate this estimate.

DETR Elko Office - Site #9823 Description: Paved parking area.

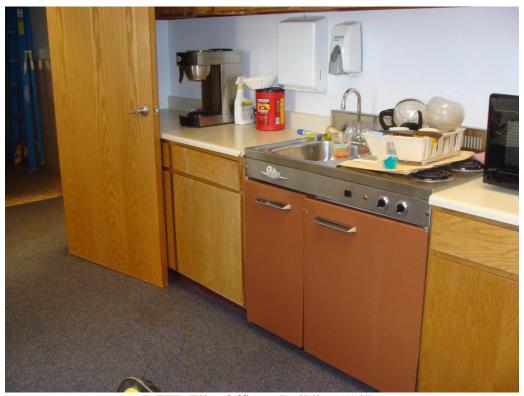
The kitchenette and associated cabinets in the employee break room are original to the building. The quality of construction and installation were inadequate for the high usage at this facility, and the cabinets and counter tops are delaminating and failing. This project recommends the replacement of the existing kitchen counters, cabinets, and associated equipment with heavy duty, quality components. The cabinets should be finished inside and outside with a melamine or similar finish which encapsulates the door, frame, and shelving. The countertops should be constructed of a highly durable product, such as stainless steel, over a moisture resistant underlayment to minimize swelling and damage from water exposure. This estimate includes disposal of the existing materials.

DETR Elko Office – Building #1476 Description: View of the break room.
